MUNICIPALITY OF MORRIS-TURNBERRY

COUNCIL AGENDA

Tuesday, January 16th, 2024, 7:30 pm

**HAZARDOUS MATERIALS SURVEY
MUNICIPALITY OF MORRIS-TURNBERRY MUNICIPAL OFFICE,
GARAGE, STORAGE SHED AND SALT STORAGE BUILDING
41342 Morris Road
Brussels, Ontario
N0G 1H0**

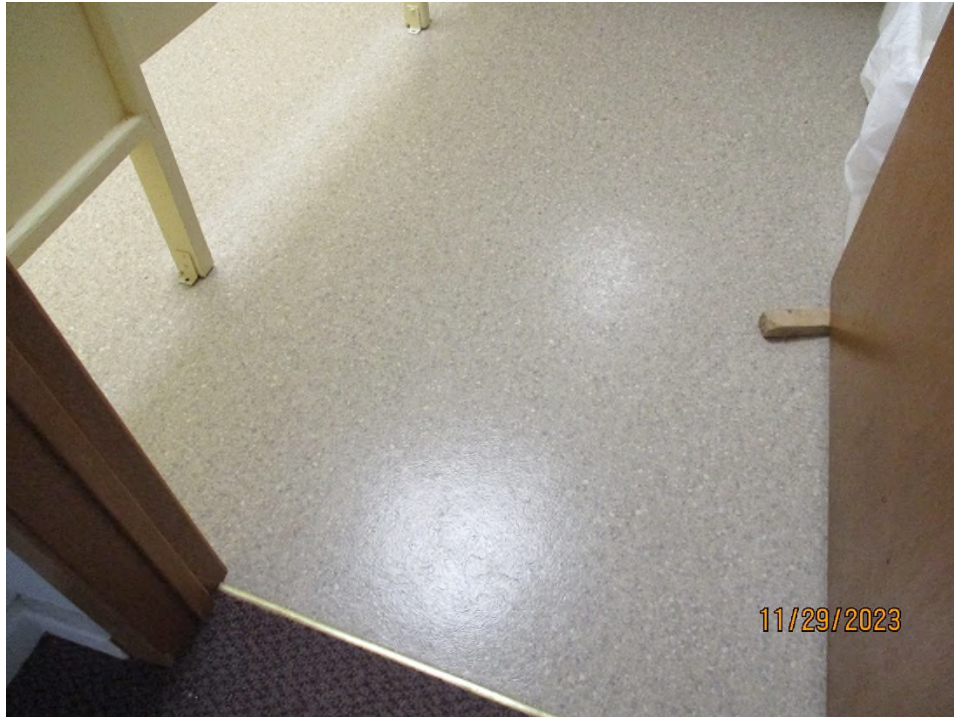
Photograph 1: View of non-asbestos linoleum in the Women's Washroom (Location 6) which is covering asbestos-containing vinyl sheet flooring, assigned a **Priority 2**.

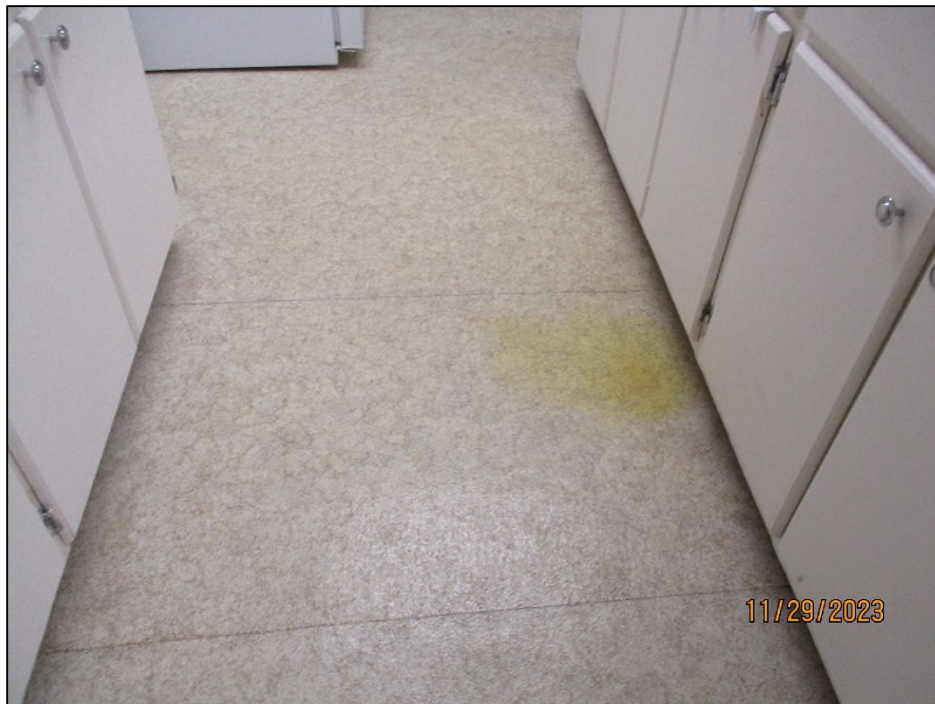
Photograph 2: View of asbestos-containing vinyl sheet flooring in the Kitchen (Location 7), assigned a **Priority 2**.

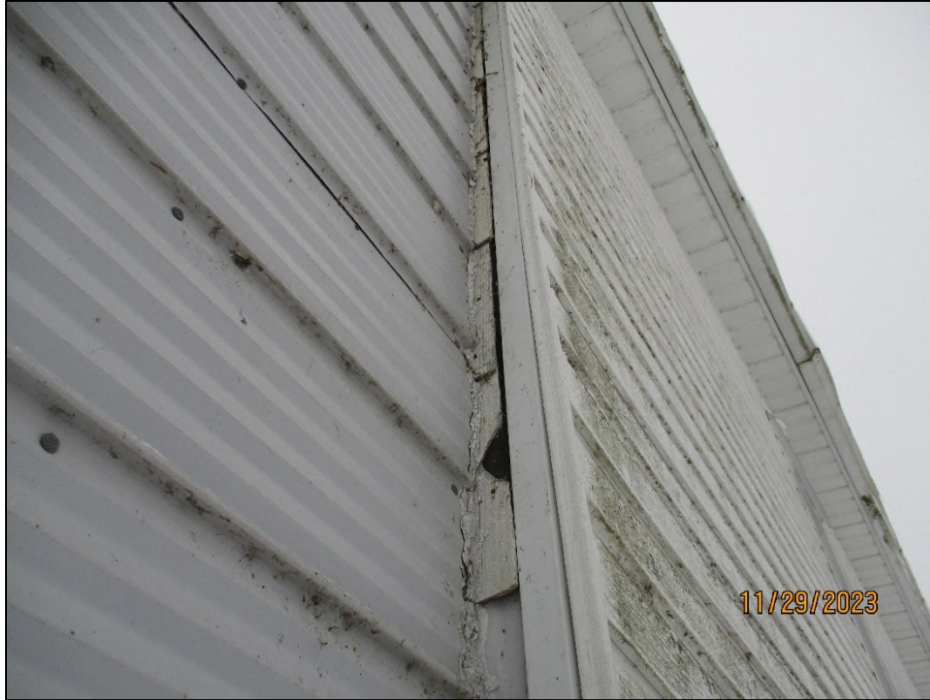
Photograph 3: View of asbestos-containing Transite Siding Shingles on the Building exterior, assigned a **Priority 2**. No shingles were observed under the vinyl siding, where accessible, however, more shingles could be present under steel or vinyl siding.

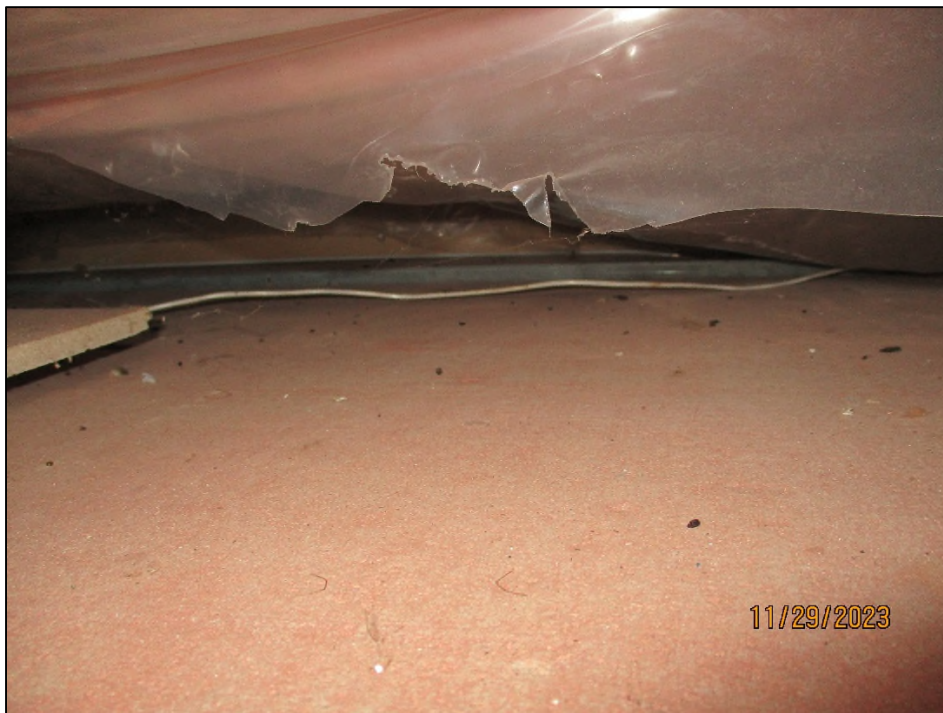
Photograph 4: View of mouse droppings on ceiling tiles in the Library Room (Location 2).

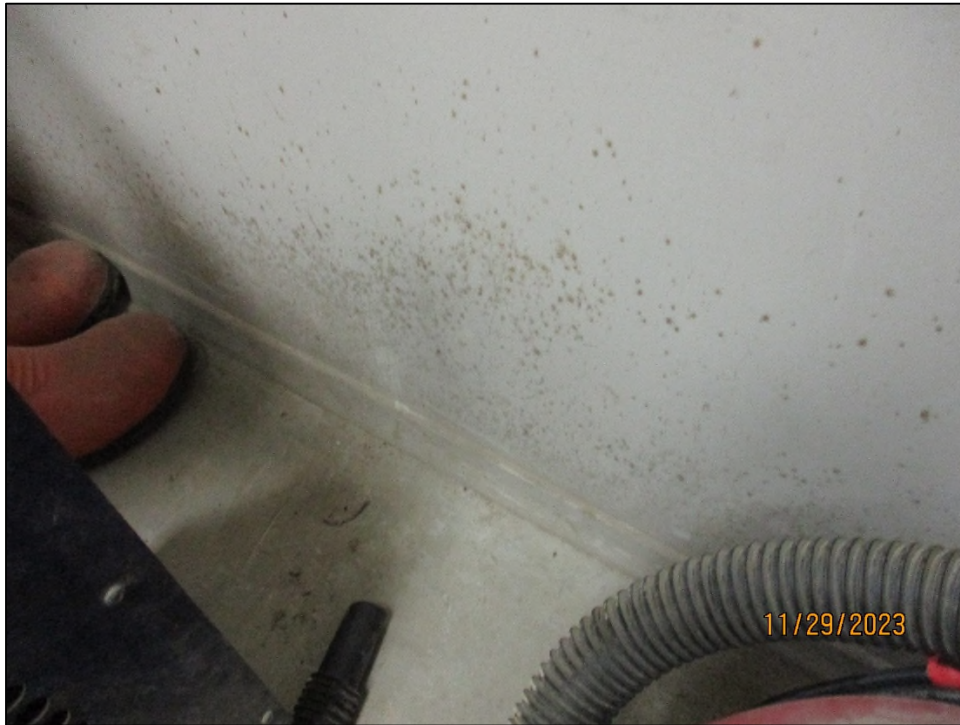
Photograph 1: View of suspect mould spotting on drywall walls in the Service Room.

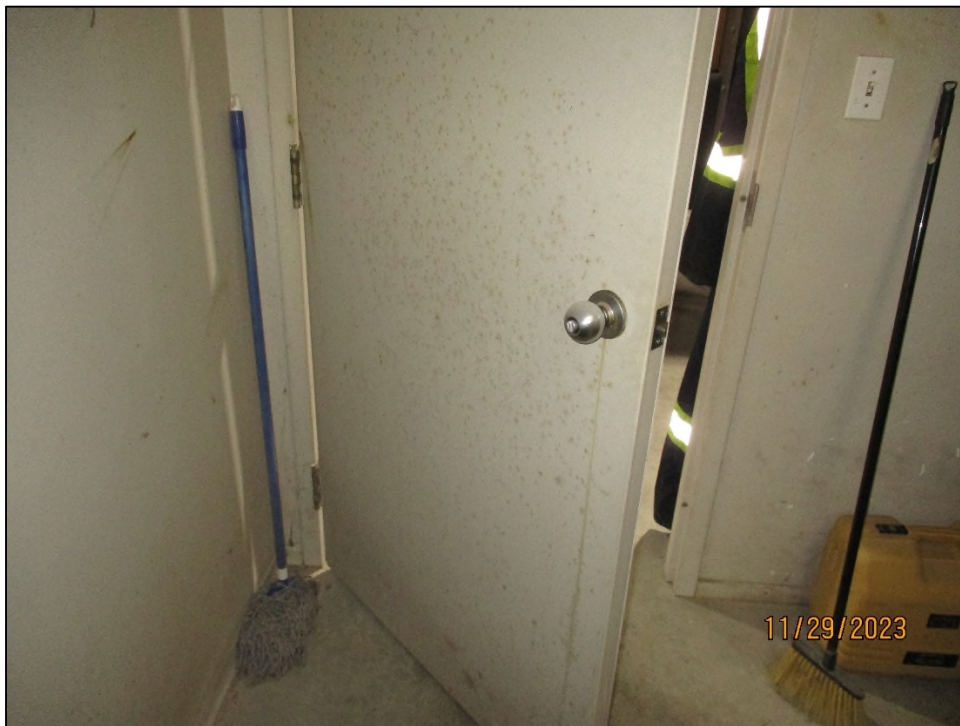
Photograph 2: View of suspect mould spotting on the wood door in the Service Room.

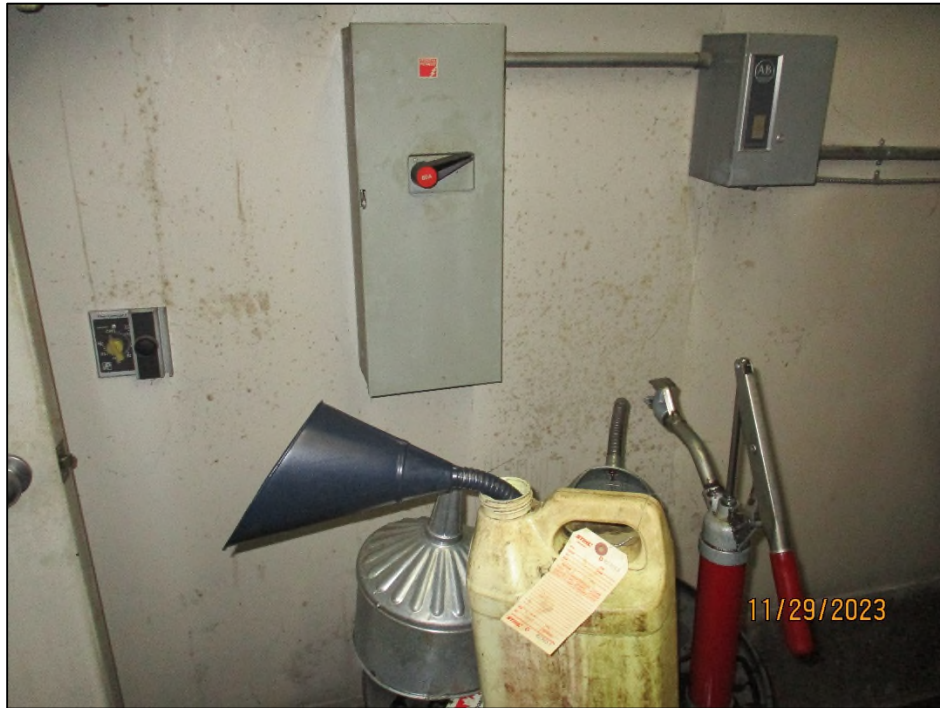
Photograph 3: View of suspect mould spotting on the drywall walls in the Parts Room.

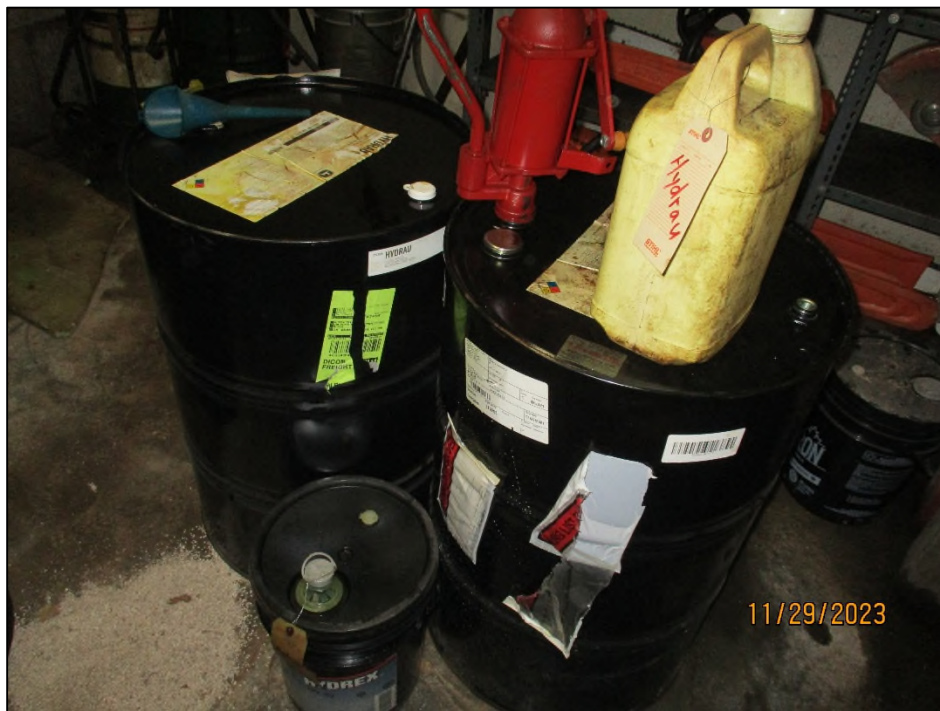
Photograph 4: View of suspect mould spotting on the drywall walls in the Parts Room.
